# GSO NDC Citation Abatement Inspection #1555050

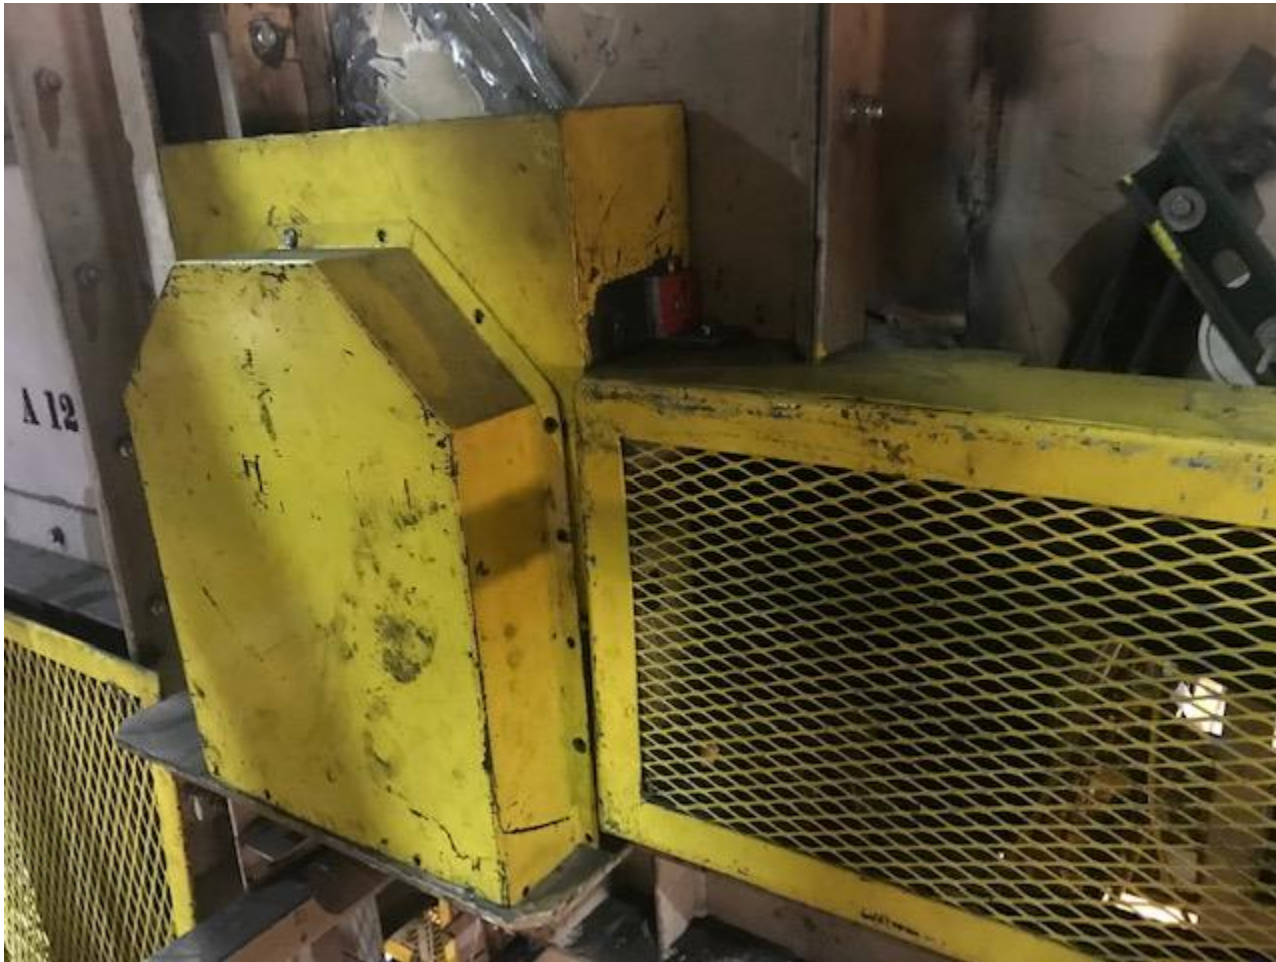
Citation 2 Item 2 (a) A-12 Guarded  
Guard Installed 11-28-2021

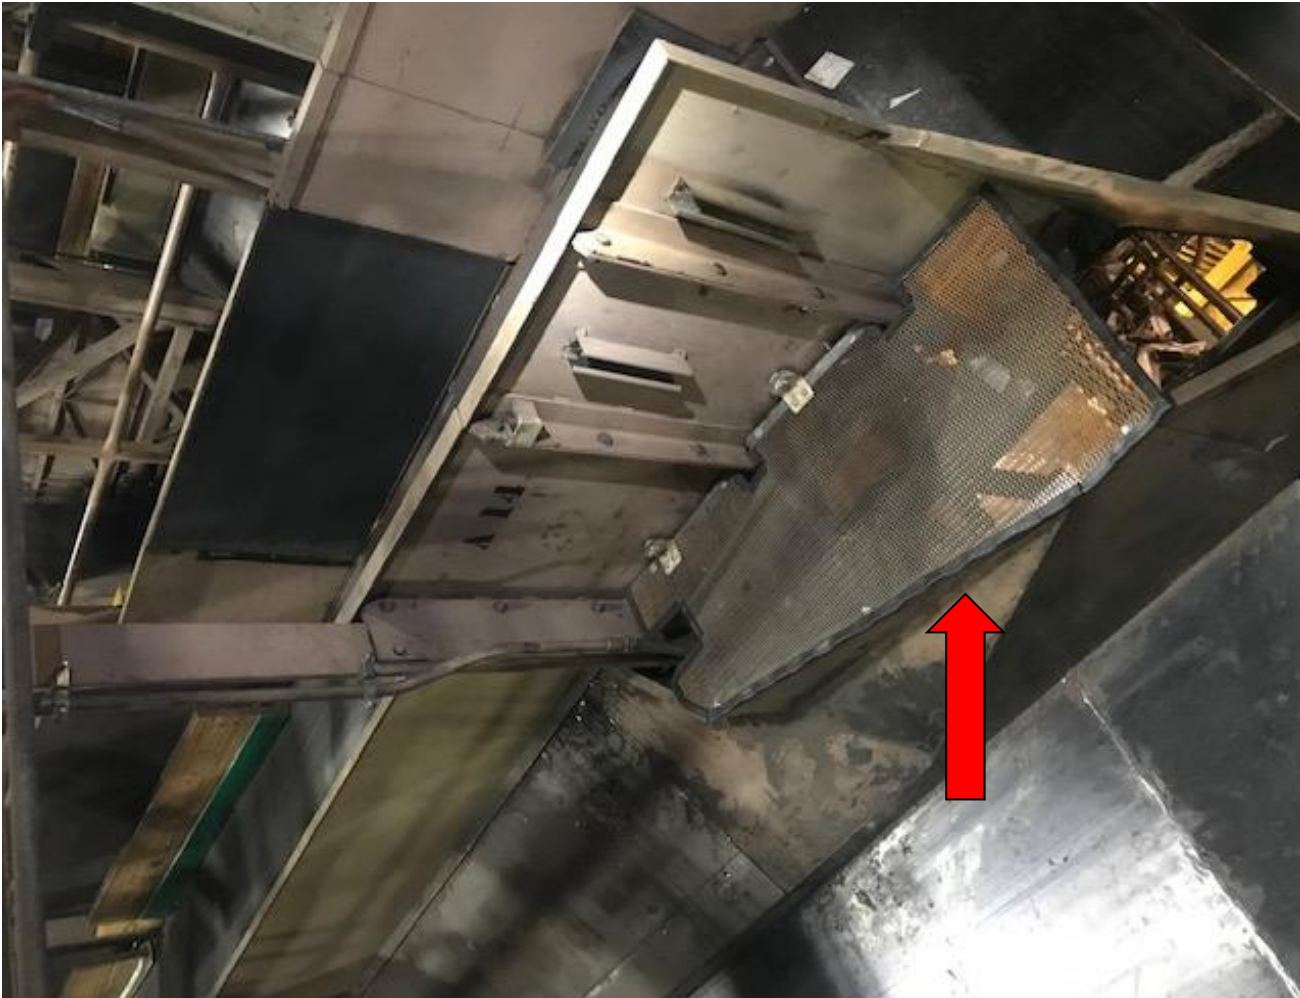
Citation 2 Item 2 (b) A 14 Guarded  
Guard Installed 02-03-2022

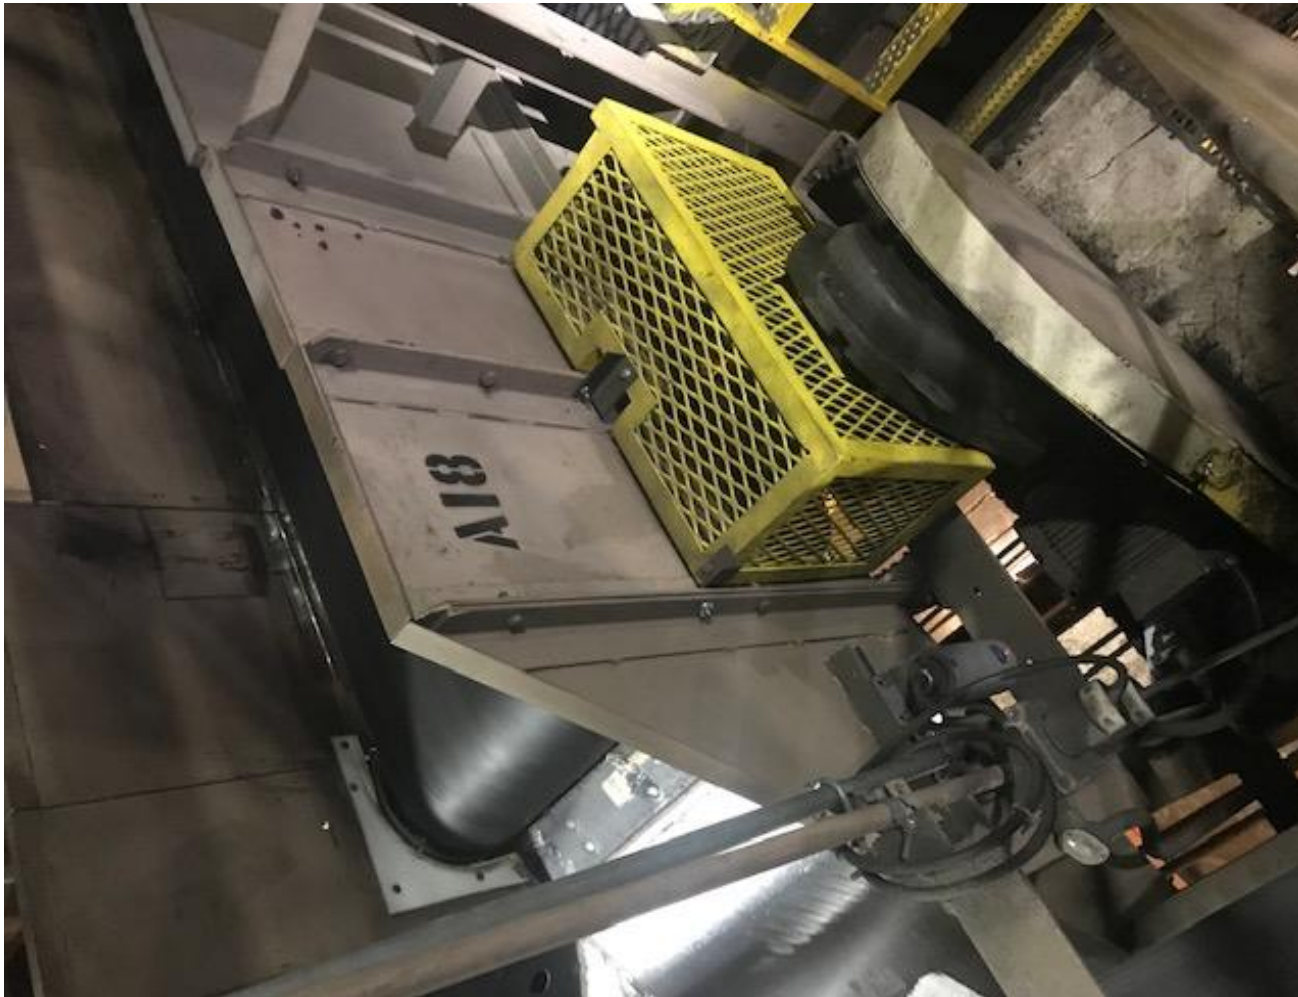
Citation 2 Item 2 (b) A 18 Guarded  
Guard extended 01-25-2022

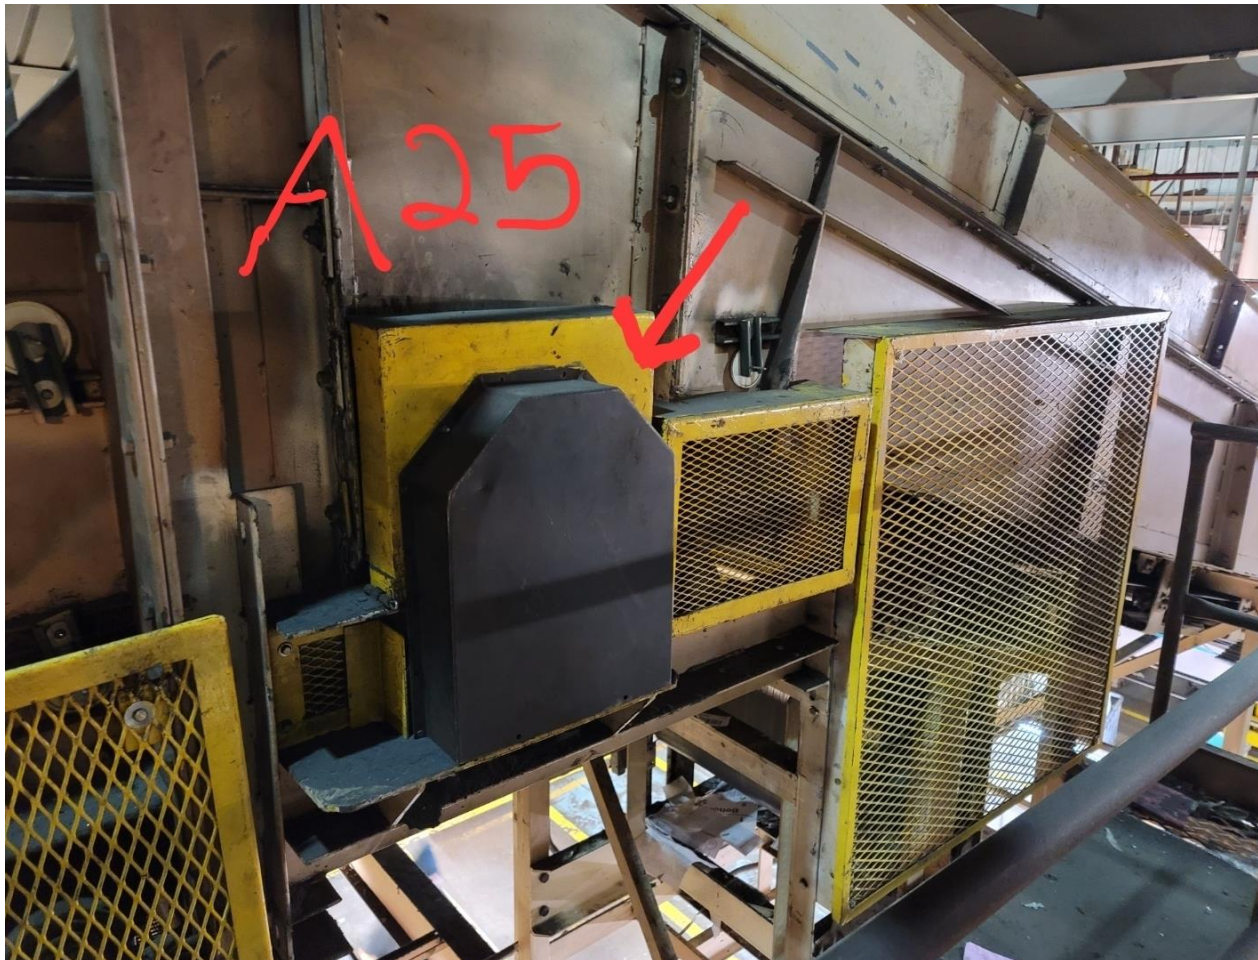
Citation 2 Item 2 (b) A 25 Guarded  
Guard Modified to Cover Hole at Bottom  
October 2021

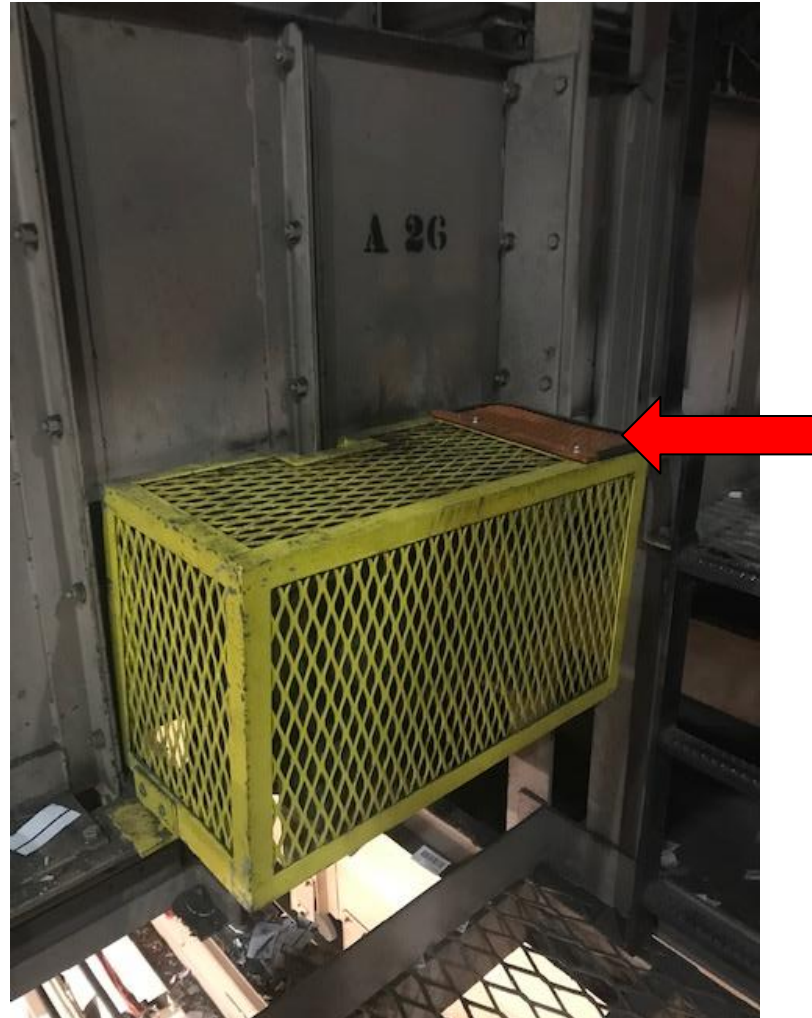
Citation 2 Item 2 (b) A 26 Guarded  
Guard Extended 1-25-2022

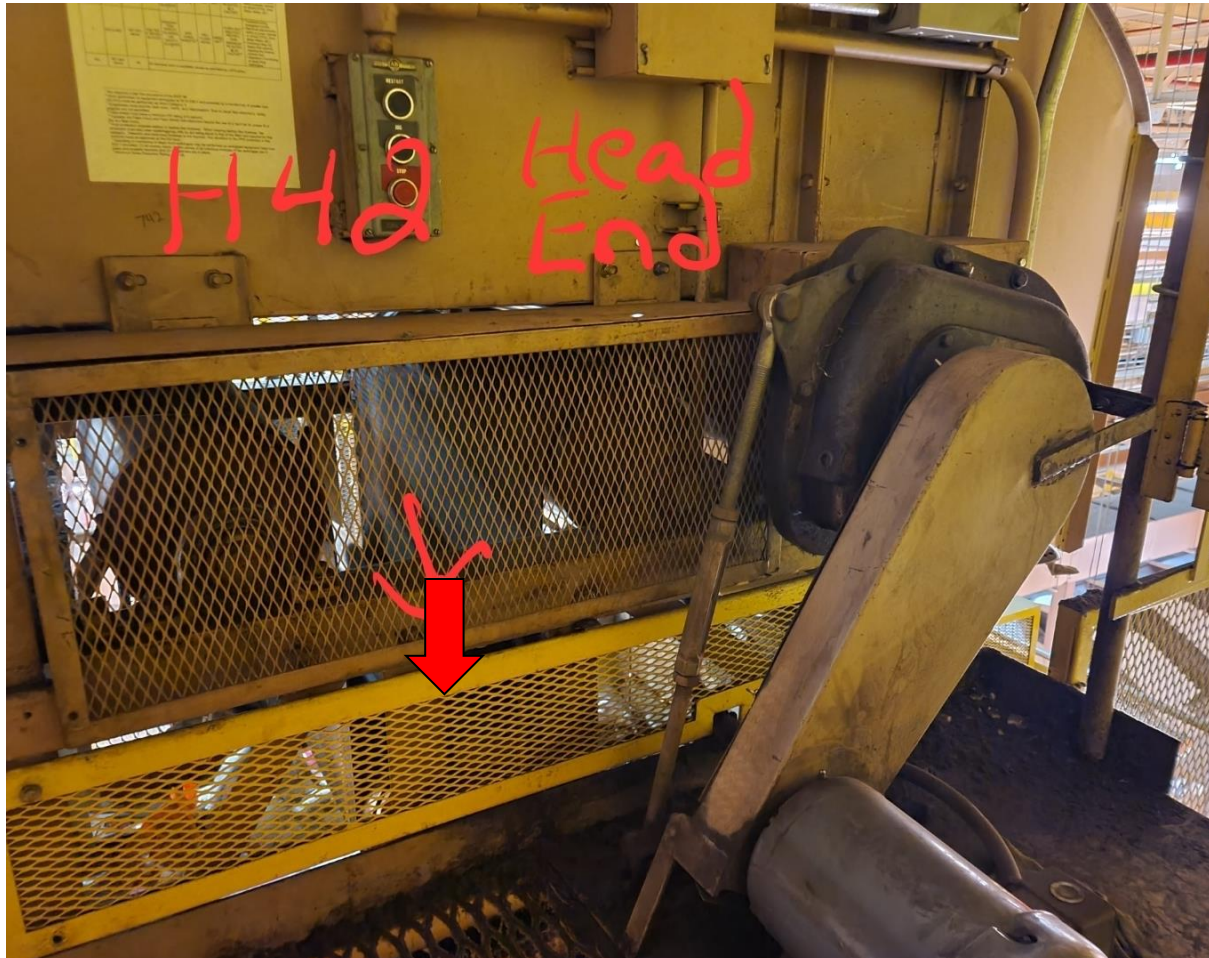
Citation 2 Item 2 (c) H 42 Guarded  
Guard installed at bottom 12-27-2021

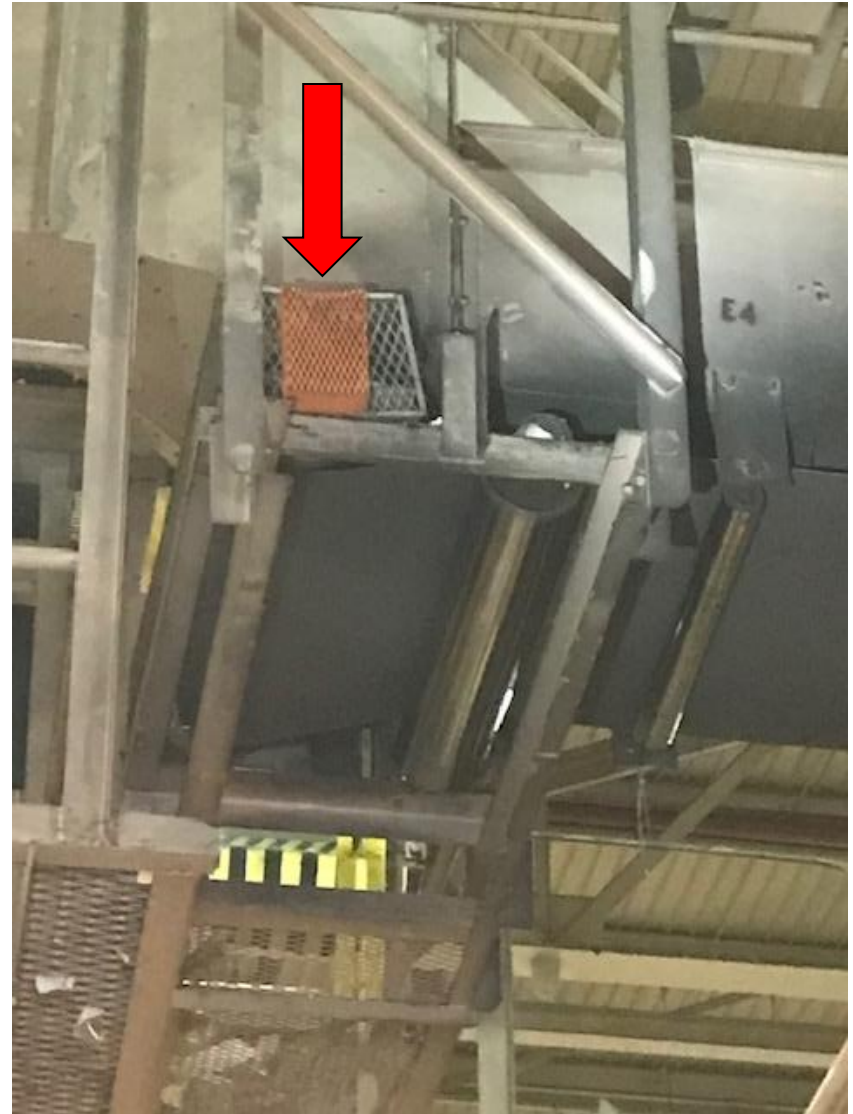
Citation 2 Item 2 (d) E4 Guarded  
Guard damaged and repaired  
02-01-2022

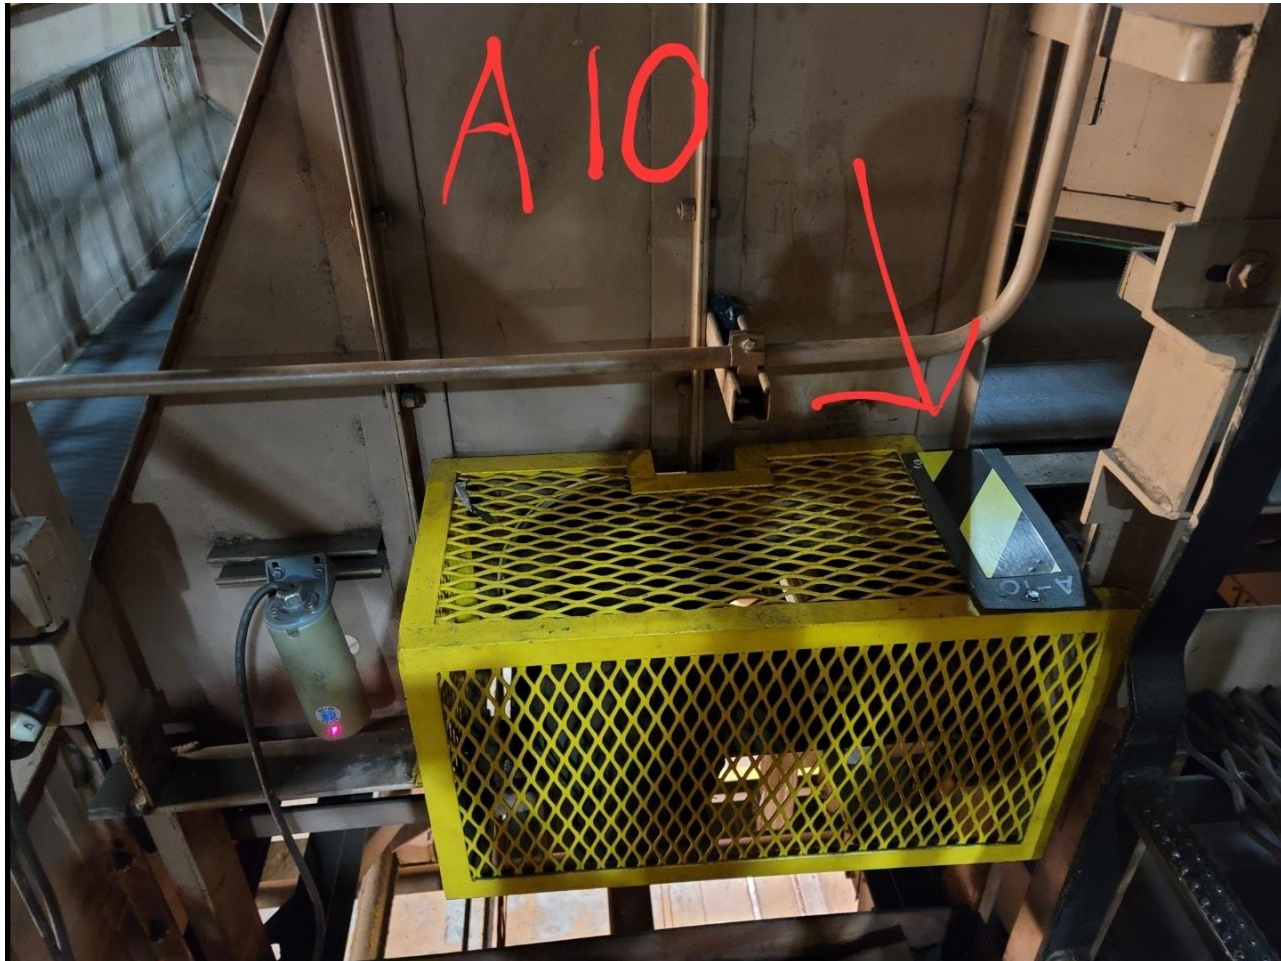
Citation 2 Item 2 (d) A 10 Guarded  
Guard extended 01-25-2022

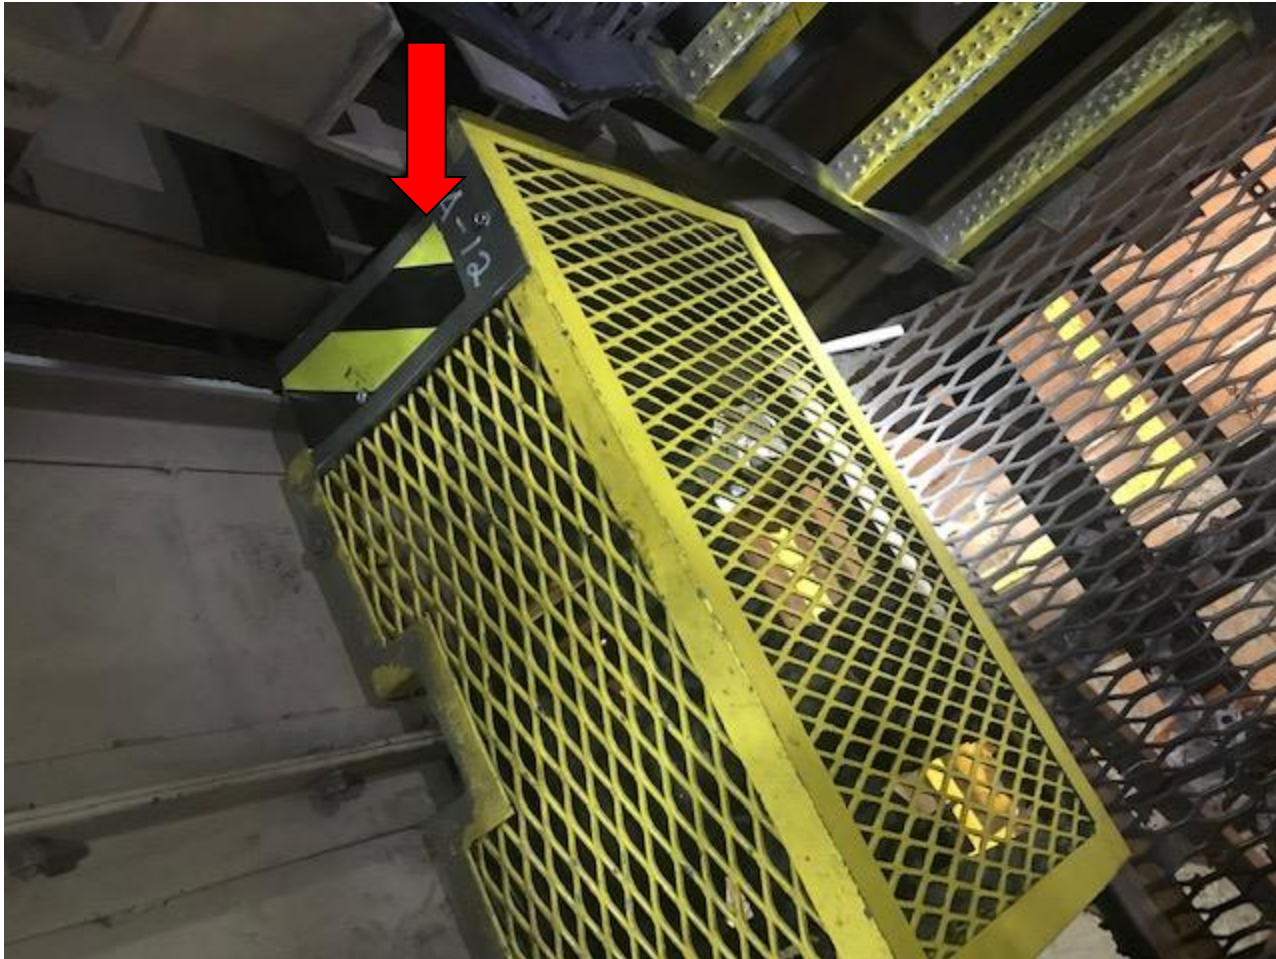
Citation 2 Item 2 (d) A-12 (back side) Guarded  
Guard Extended 1-25-2022

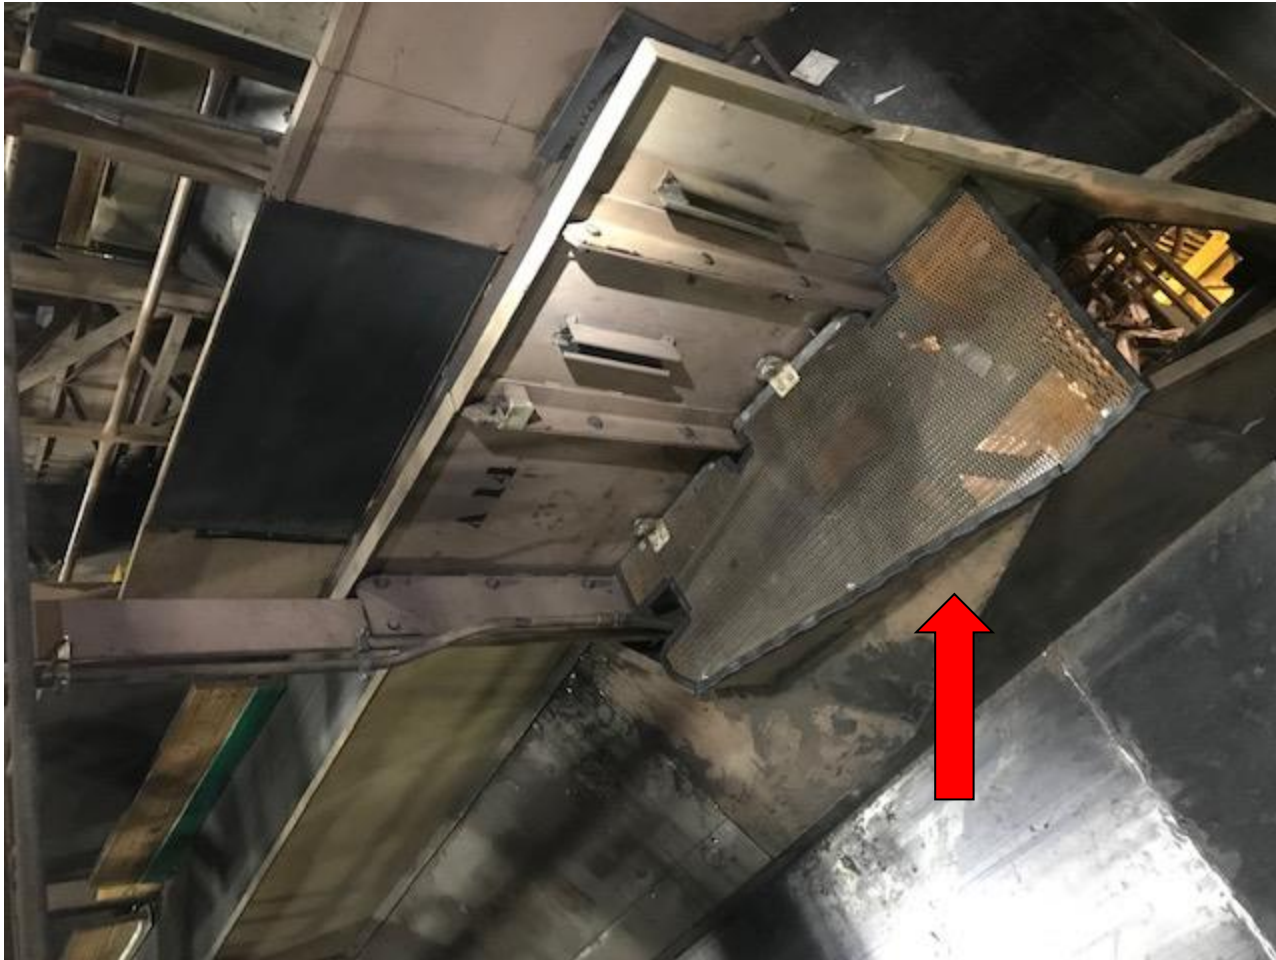
Citation 2 Item 2 (d) A 14 Guarded  
Guard Installed 02-03-2022

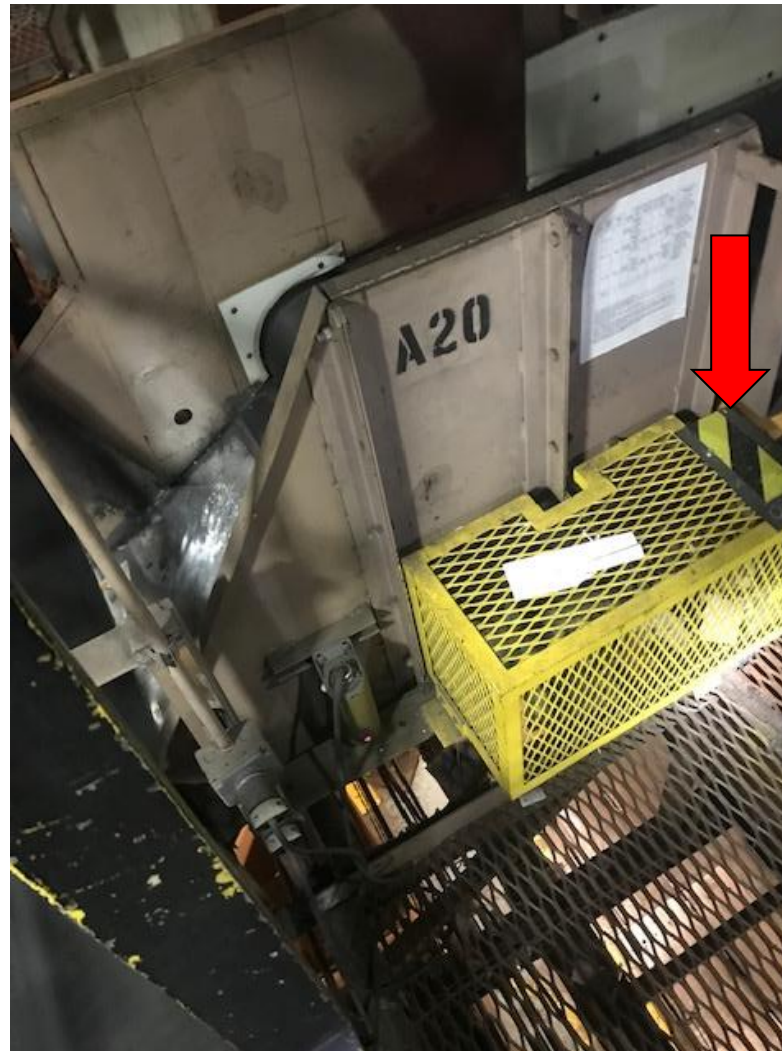
Citation 2 Item 2 (d) A-20 Guarded  
Guard Extended 01-25-2022

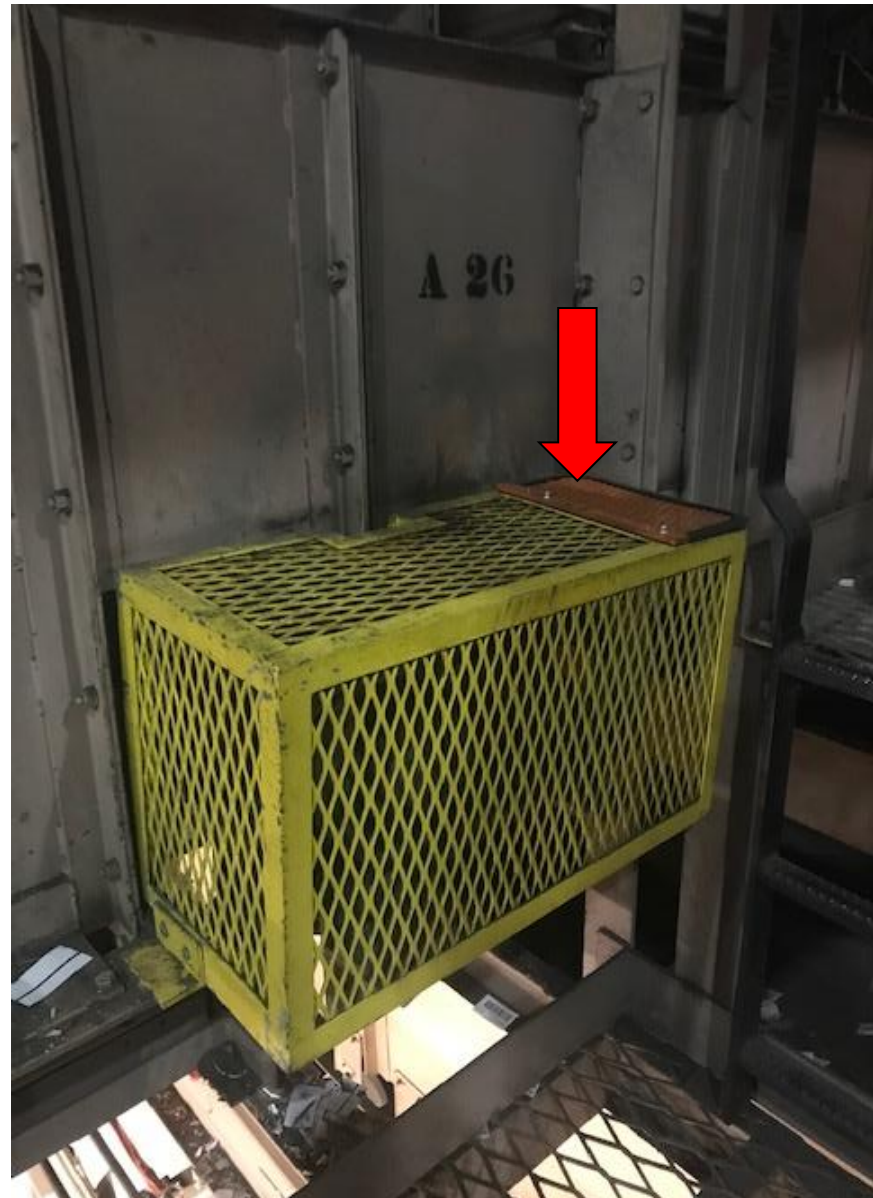
Citation 2 Item 2 (d) A 26 Guarded  
Guard Extended 01-25-2022

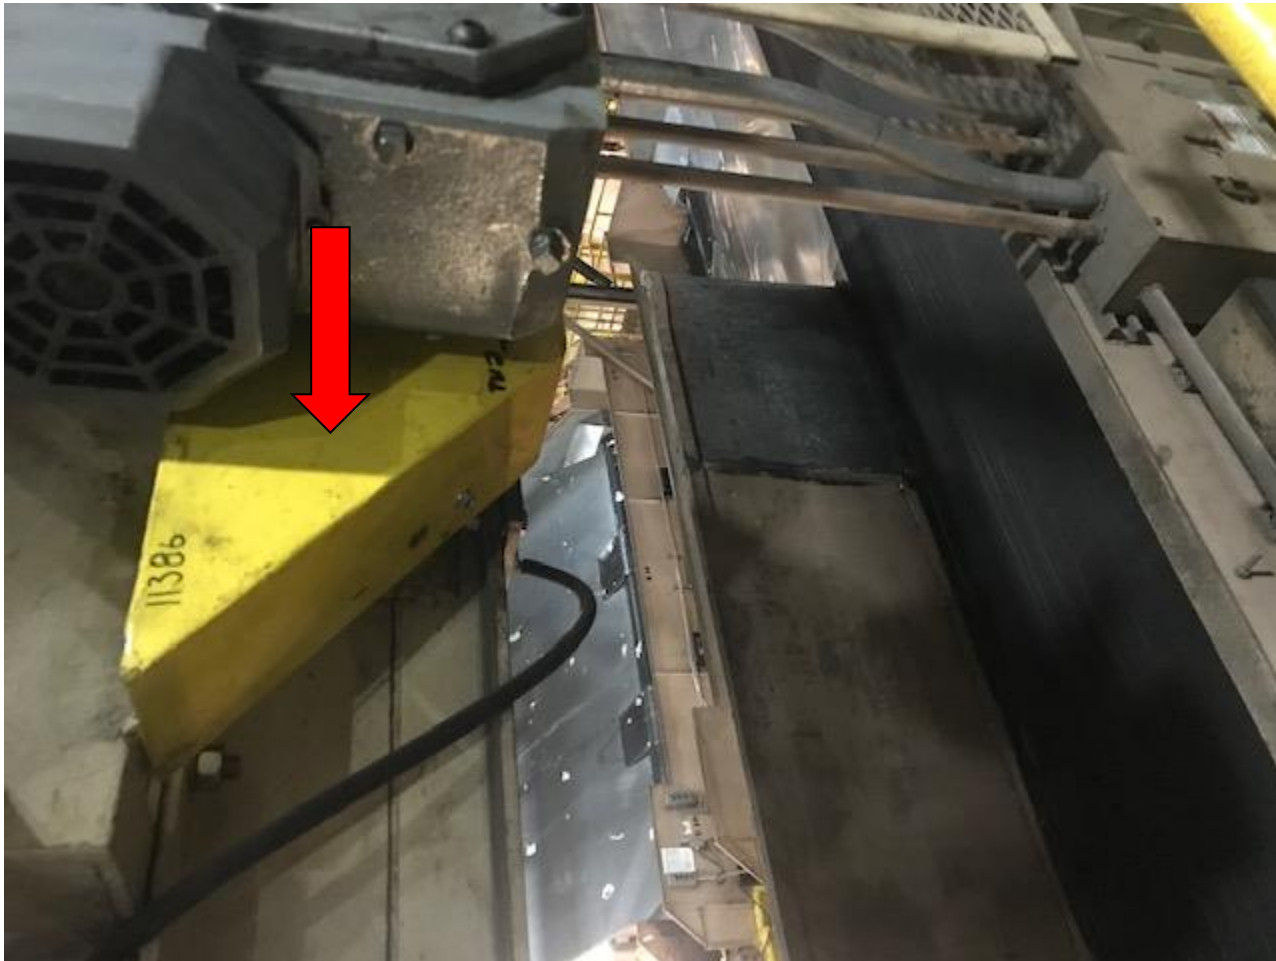
Citation 2 Item 2 (d) G 4 Guarded  
Guard Installed 01-28-2022

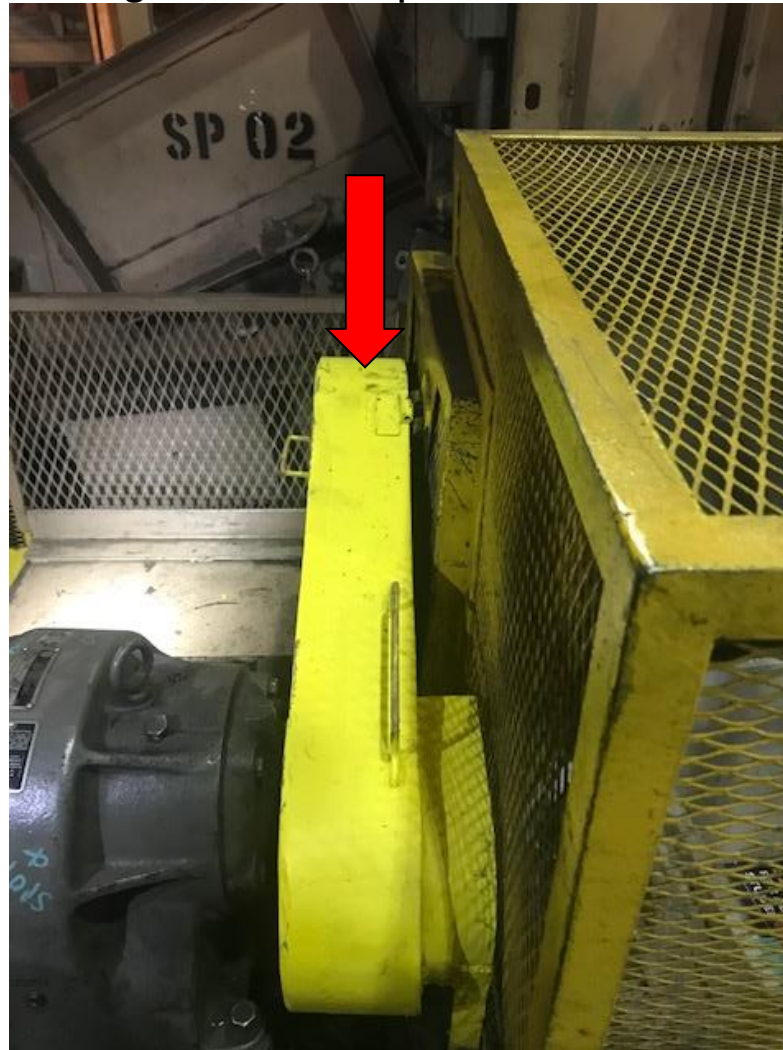
Citation 2 Item 2 (d) SP 02 Guarded  
Damage Guard Repaired 02-01-2022

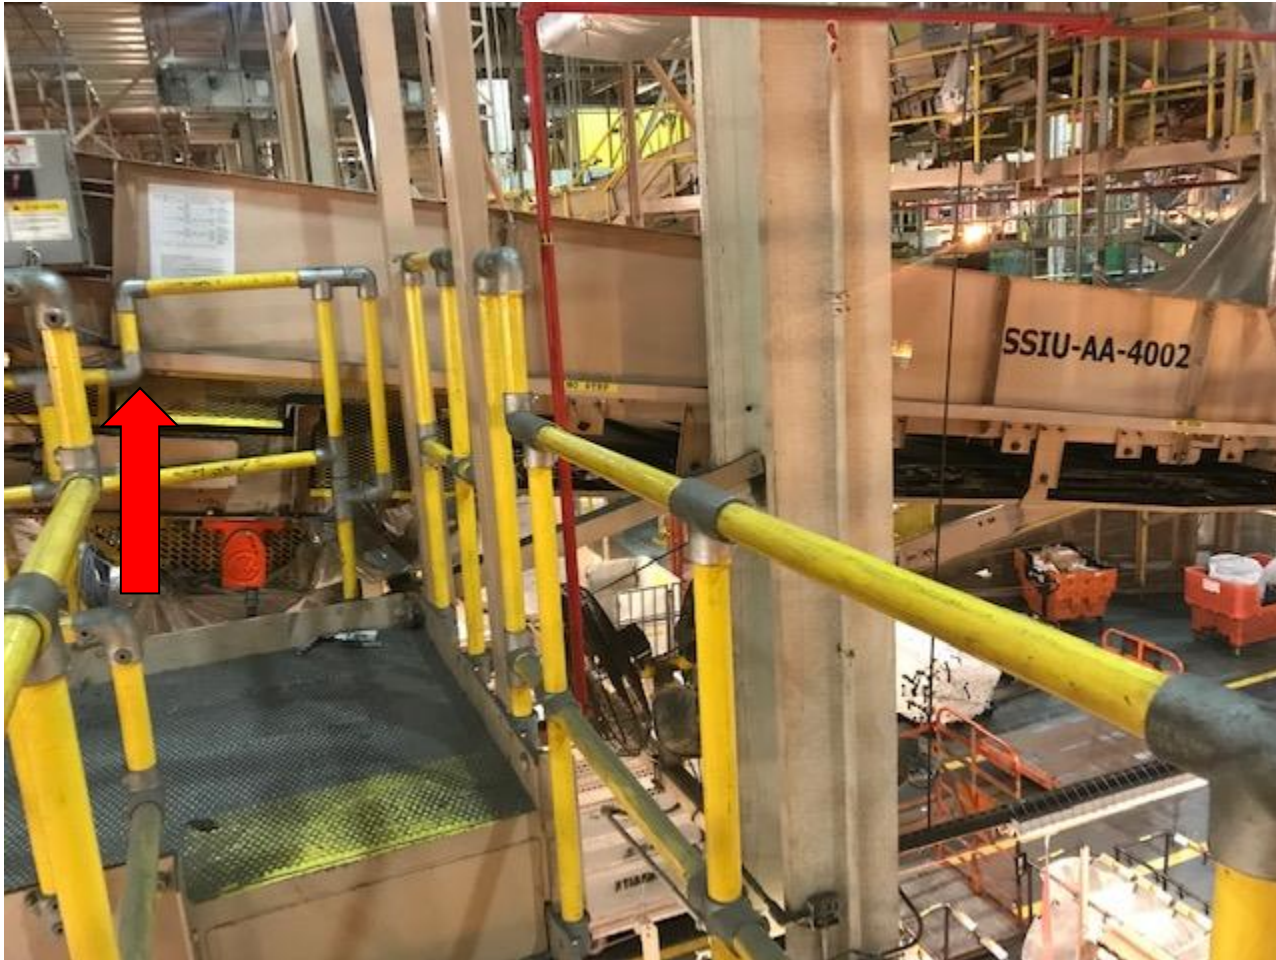
Citation 2 Item 2 (e) 4002 Guarded  
Guard installed 12-14-2021

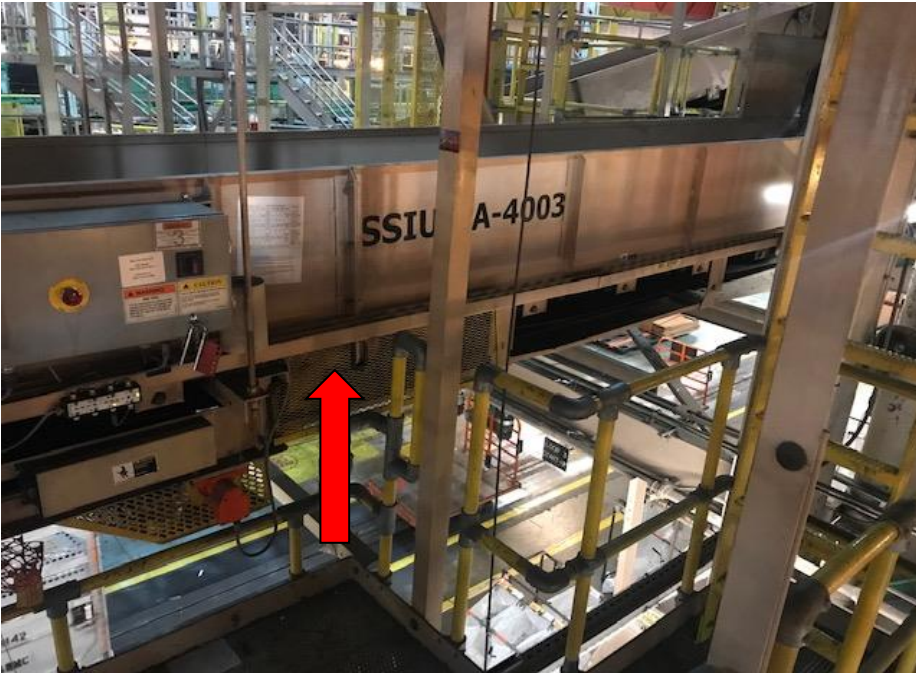
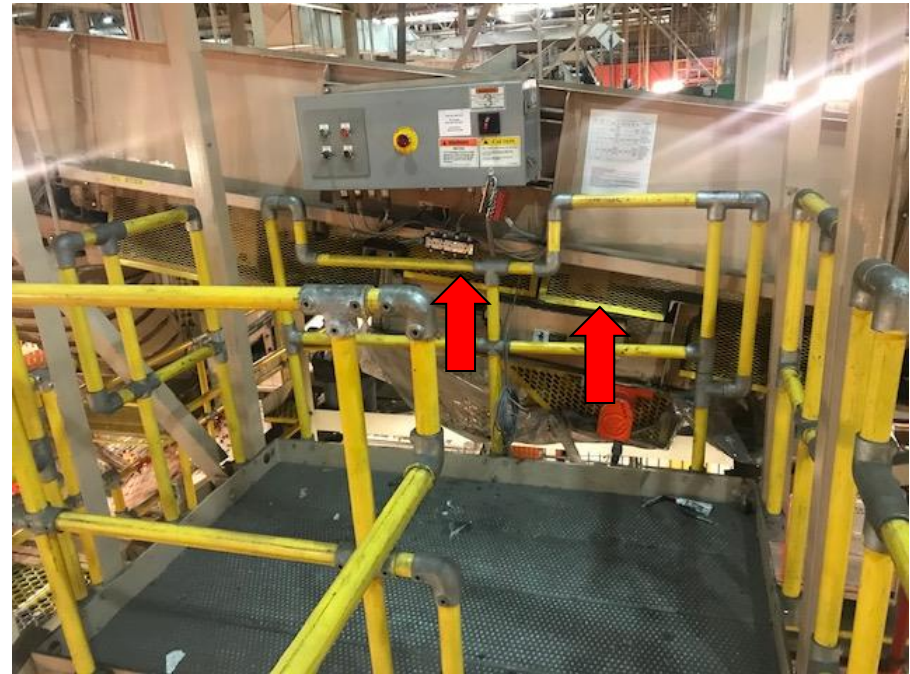
Citation 2 Item 2 (e) 4003 Guarded  
Guards Installed 12-14-2021

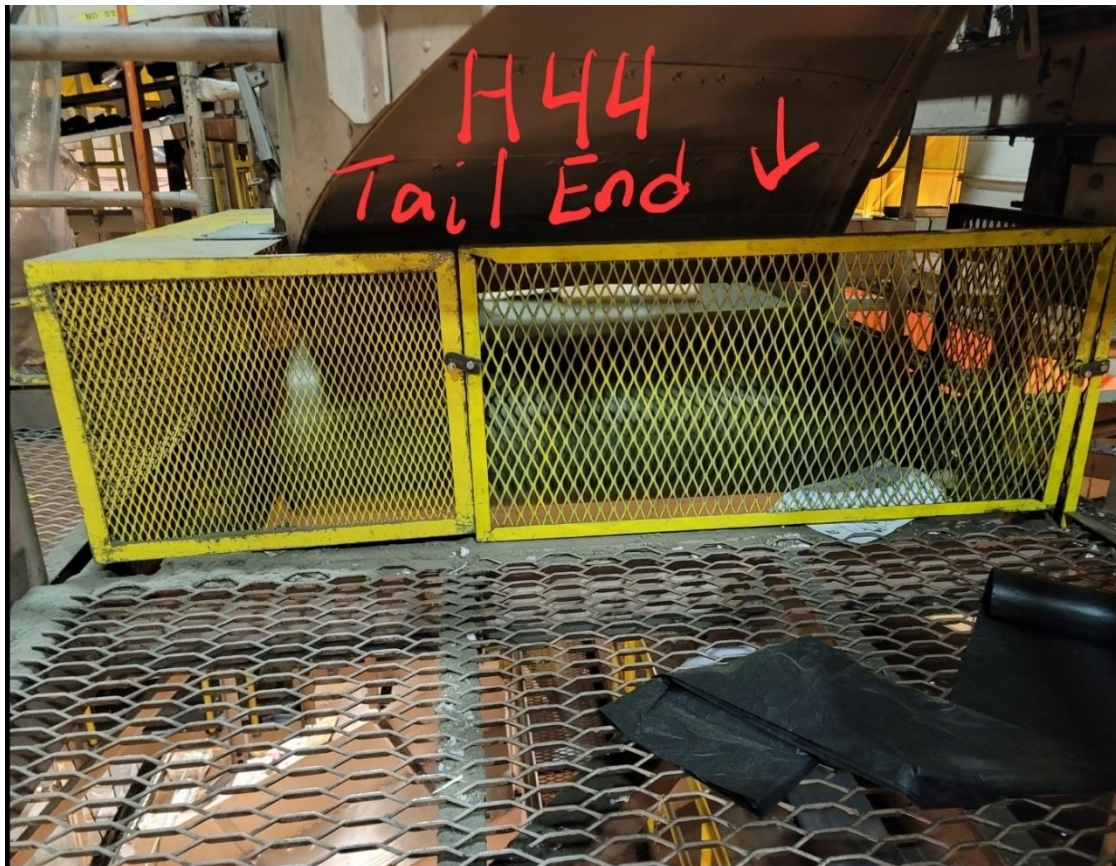
Citation 2 Item 2 (e) H 44 Guarded  
Guard Modified to Mount Securely  
02-18-2022

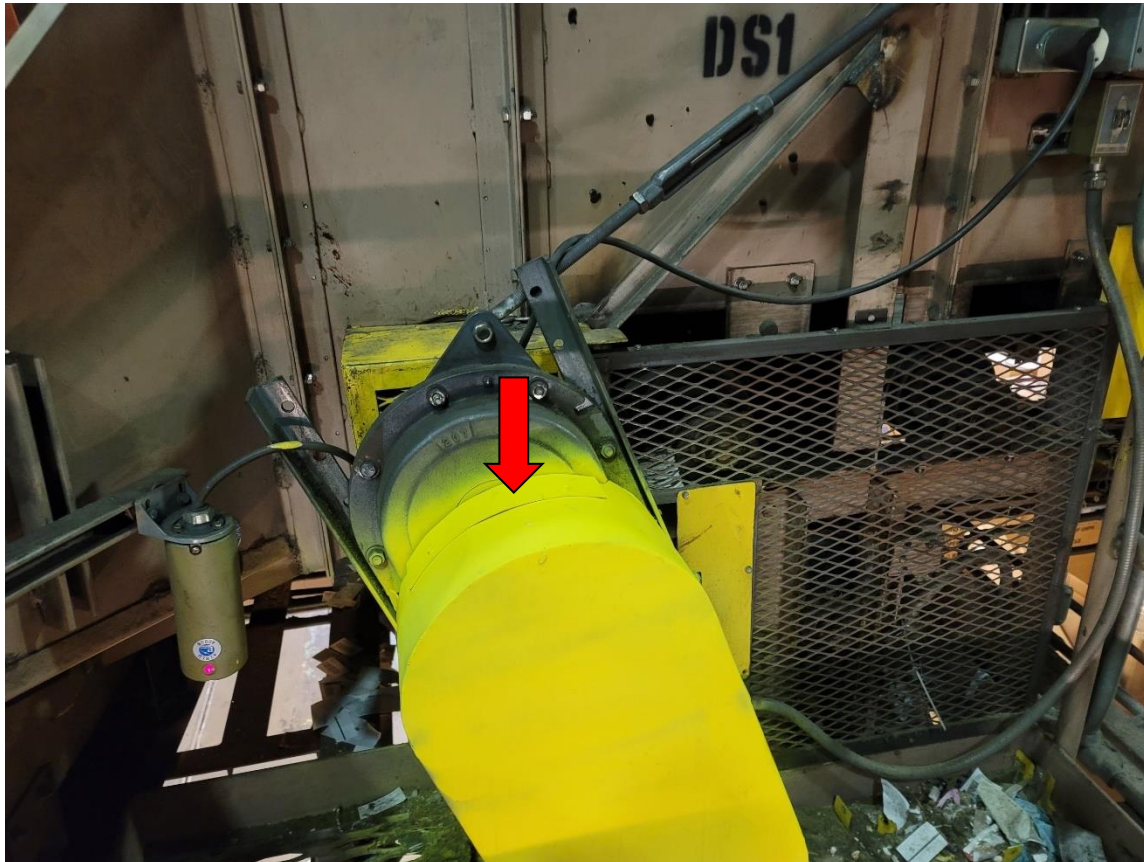
Citation 2 Item 2 (e) DS1 Guarded  
Small Hole Damage Repaired on Guard 03-15-2022
